RCRA FACILITY ASSESSMENT REPORT

DIGITAL EQUIPMENT CORPORATION

SAN GERMAN, PUERTO RICO

AIDA T. FUENTES RIVERA  
EQB LAND POLLUTION CONTROL AREA  
HAZARDOUS WASTE DIVISION  
OCTOBER 1990

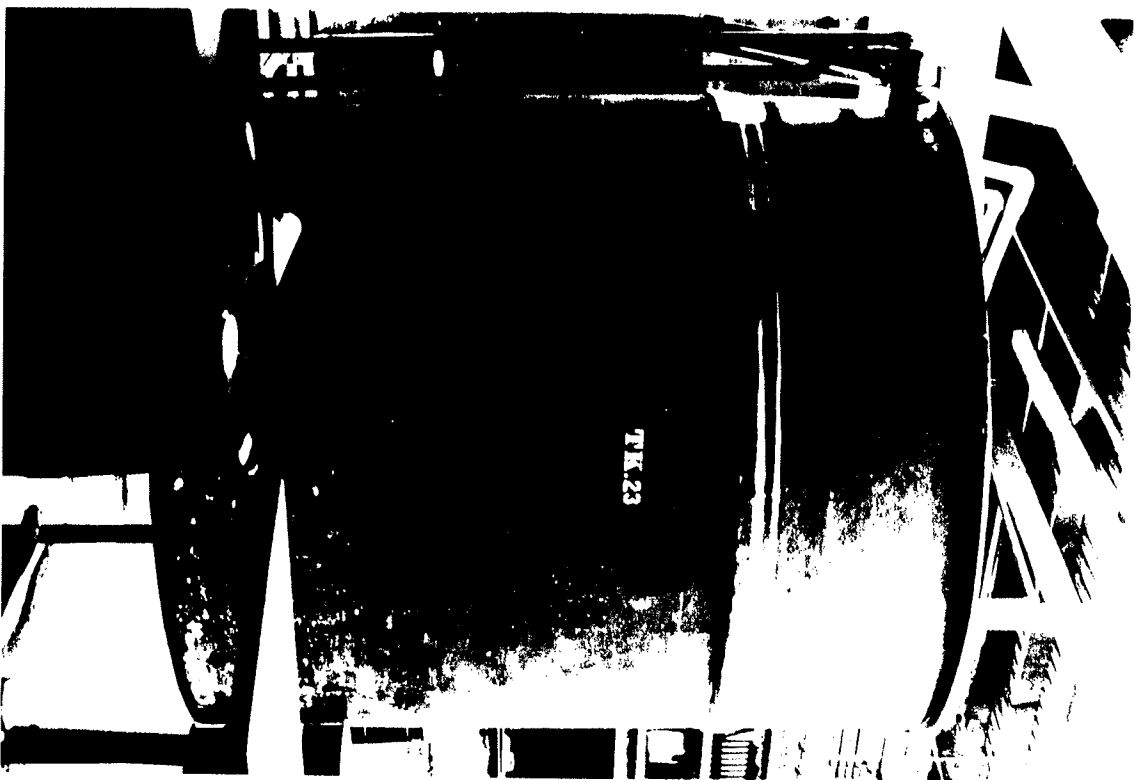
Photo no 31 : Filter Press Feeding Tank, 3,000 gallon,  
at the Wastewater Treatment Plant.

Note : TK-23 was formerly used for storage  
of Feov sludge prior to out-site disposal.
